Aviation Investigation Preliminary Report

Location:	Auburn, WA	Accident Number:	WPR24FA182
Date & Time:	June 6, 2024, 11:59 Local	Registration:	N412JN
Aircraft:	VANS AIRCRAFT INC RV-12	Injuries:	1 Fatal
Flight Conducted Under:	Part 91: General aviation - Personal

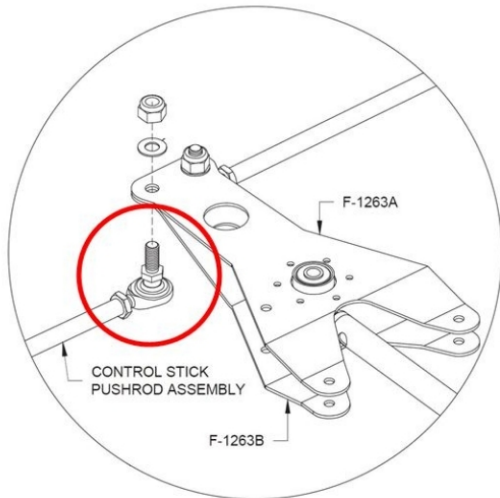
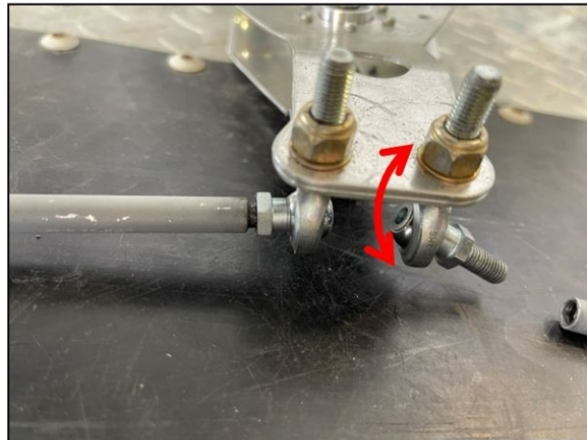
When compared with the airplane's plans, the inboard eyebolts were installed such that the eyebolt stud was connected to the pushrod, and its body to the mixing bellcrank, rather than the other way around (see figure 2). In this configuration, the stud end of the eyebolt was free to rotate within the threaded inboard section of pushrod.

Figure 2 – Installation of the CM-4MS eyebolt per plans on the left vs the installed eyebolt on the accident airplane as found on the right.
