RVator's Log

Newsletter of the Twin Cities RV Builder's Group

"Miracle on Hatfield Lake"

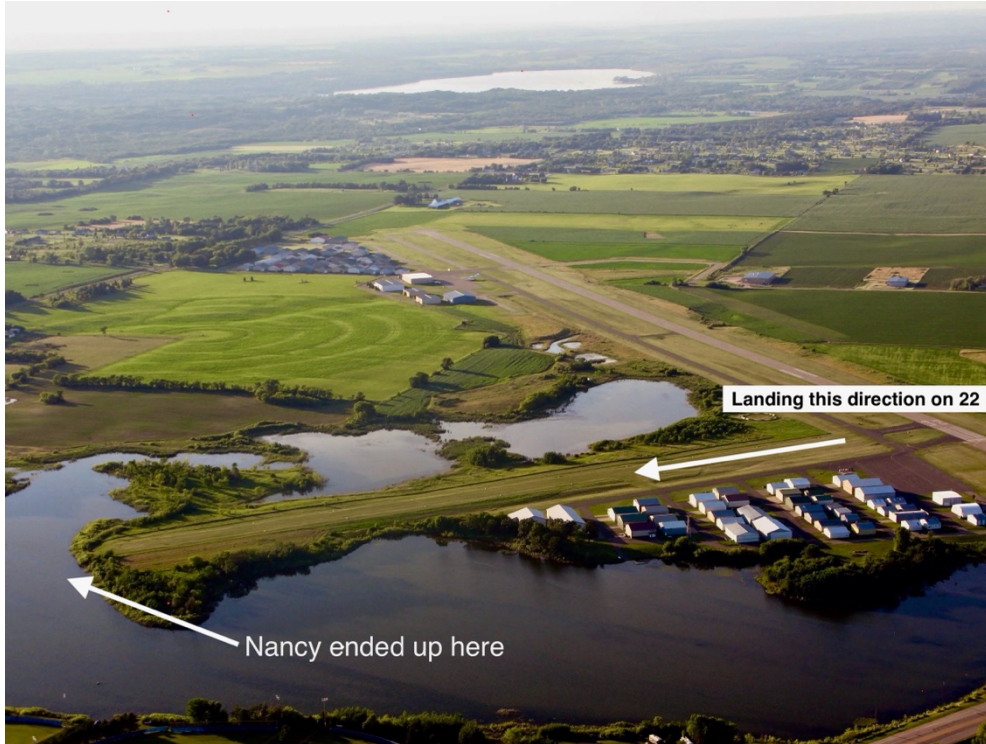
KRNH looking to the northwest
